TR TRANSFORMATION

Tim McDonald discovered that although car restoration takes its toll of time and patience, it is ultimately rewarding. Arnold Wilson describes the process in words and pictures

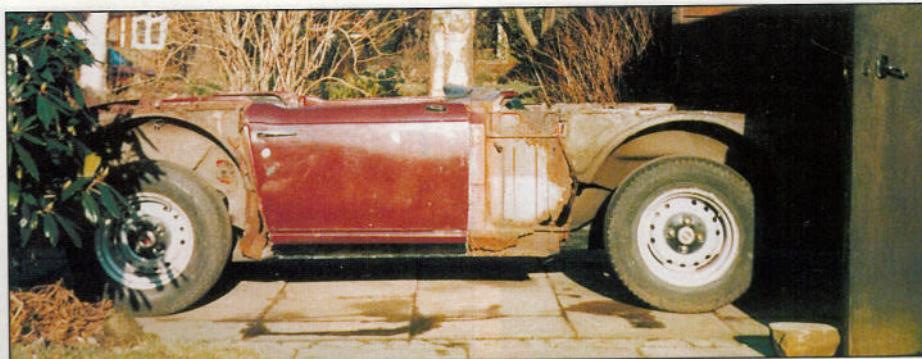
Removing the front wings should have been a simple unbolting job until Tim realised that one had been welded on while the other was bonded in with a large quantity of glassfibre matting and resin. He had hoped that most of the corrosion would be limited to the outer panels but after removing them he was horrified to discover that the inner wings, much of the floor including the boot, both B-posts and the outer and inner sills were all skeletal, consisting mainly of brittle ferric oxide. The whole lot would have to be replaced.

Above, once the wings were off, it was the same old story - rampant corrosion everywhere

Again, being new to the game, Tim took advice from others who had trodden the same path before him and as a result decided to replace the inner panels one-by-one while the shell was still on the chassis, thereby ensuring, according to the professionals, a much more accurate panel fit, particularly when it came to replacing the outer panels such as the wings, bonnet, etc. Not being an expert, Tim spent much time photographing and measuring

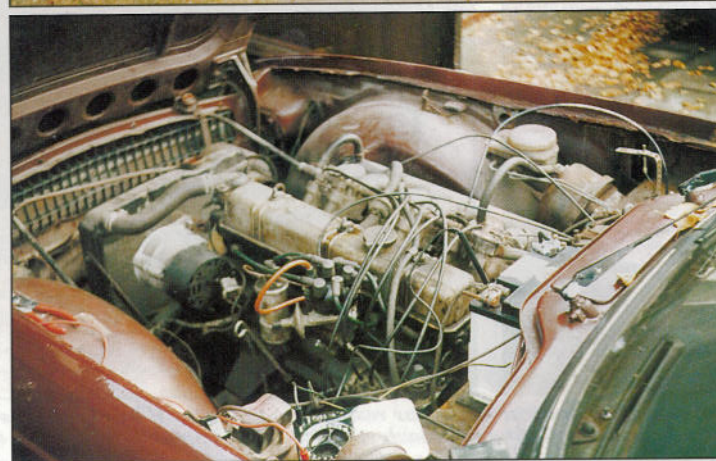
Tim's TR6 has the 150bhp fuel-injected engine and as the car was emitting clouds of blue smoke and running rough and rich, he realised that the Lucas metering unit was very definitely out of adjustment. Rather than have it recalibrated, however, he fitted a new one along with six new injectors. The rest of the injection system, including the high-pressure pump in the boot, was quite satisfactory and was re-installed.

Left, the 150bhp engine required a fairly drastic rebuild and some attention to the injection system

various components. The bores in the six-cylinder Triumph engine are usually in good order but Tim decided to have a 10 thou' rebore and had the crankshaft reground at the same time. The block was rebuilt with new main, big-end and little-end bearings, plus a set of new oversize piston rings. Tim took the cylinder head to a local machine shop where it was skimmed, the valve seats recut and new valves and springs fitted. Back in the garage, the reassembly continued with the refitting of the original unworn camshaft, a new timing chain and new front and rear oil seals. A new water pump was installed and a reconditioned alternator fitted for good measure.

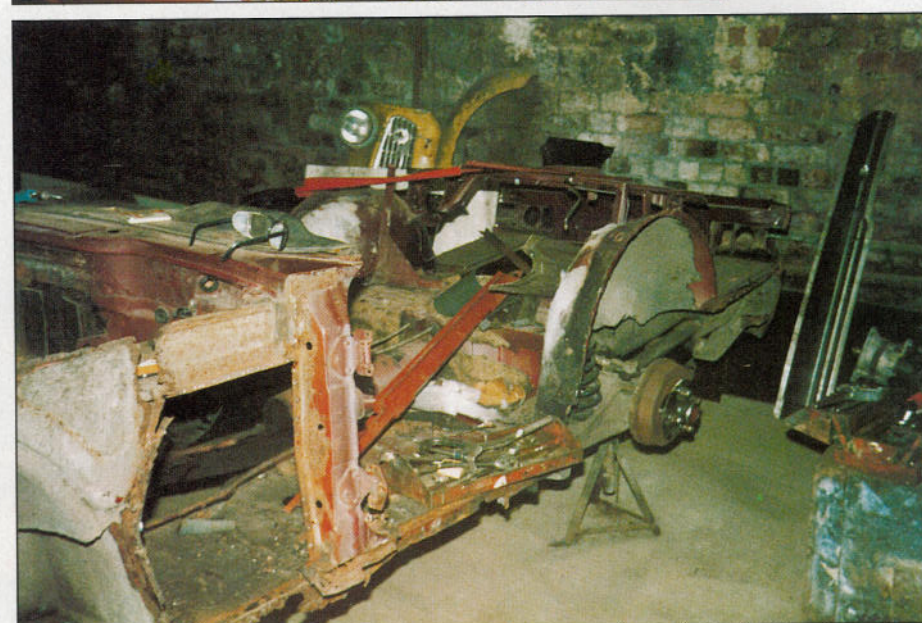
Above, a huge amount of work had to be carried out on the car's basic structure; the body was left on the chassis for this to ensure accurate panel alignment

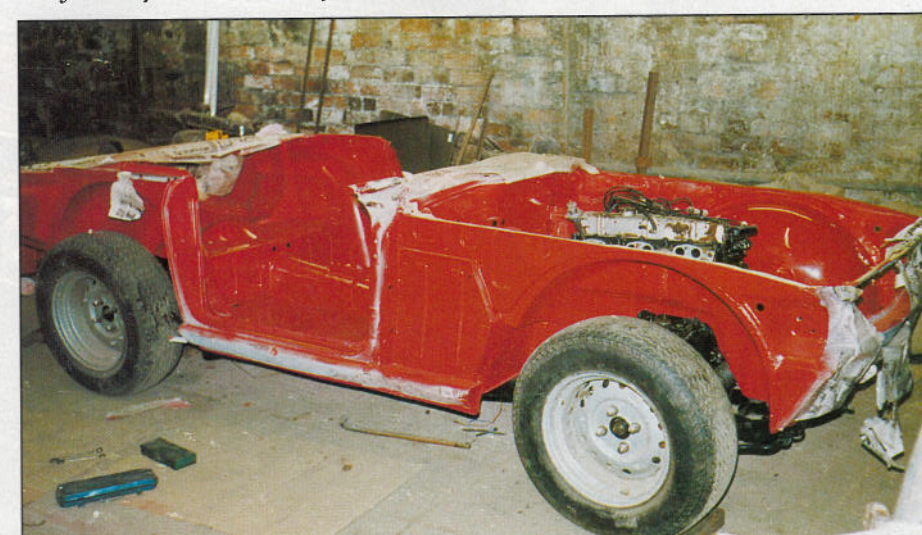
Tim practised his spraying techniques by tackling the rebuilt inner panels first

As our man had not done any serious spraying, he talked to a professional painter, borrowed a compressor and treated himself to a new spray gun. The read-up theory was put into practice on the inner body panels and by the time Tim was ready to paint the visible outer panels (wings, bonnet, etc) he had become a very proficient sprayer. He recalled with obvious pleasure: "There is a terrific sense of achievement when you spray on the final colour coat which is glossy and wet and on the point of running, but it doesn't and you go back to look at it after two or three minutes and it looks perfect."
