TR TRANSFORMATION

Tim McDonald discovered that although car restoration takes its toll of time and patience, it is ultimately rewarding. Arnold Wilson describes the process in words and pictures

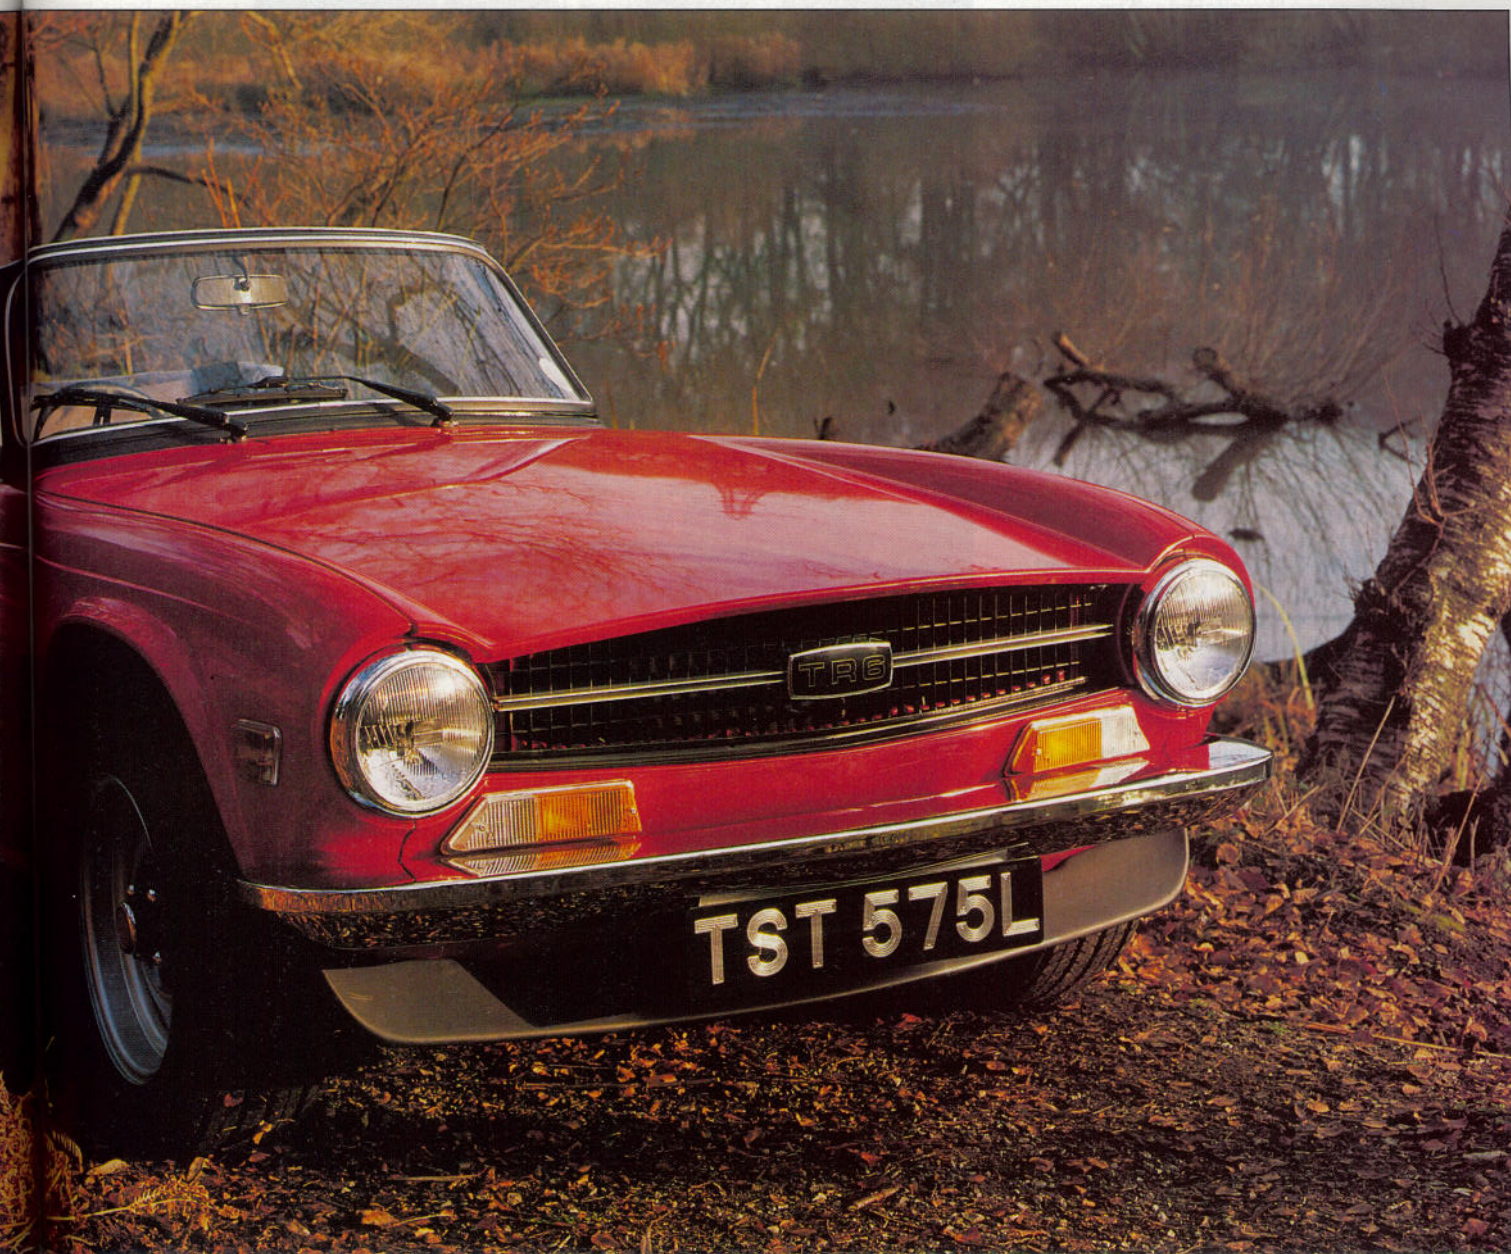
Tim McDonald was very much an amateur at the car restoration game until he took on a semi-derelict TR6 bought for £995 in 1986. Learning as he went along, his painstaking approach resulted in an immaculate British sports car currently valued at £15,000
